# Facility Conditions Assessment

## Town of Lansing Highway Department Building

**Final Report**  
**November 10, 2021**

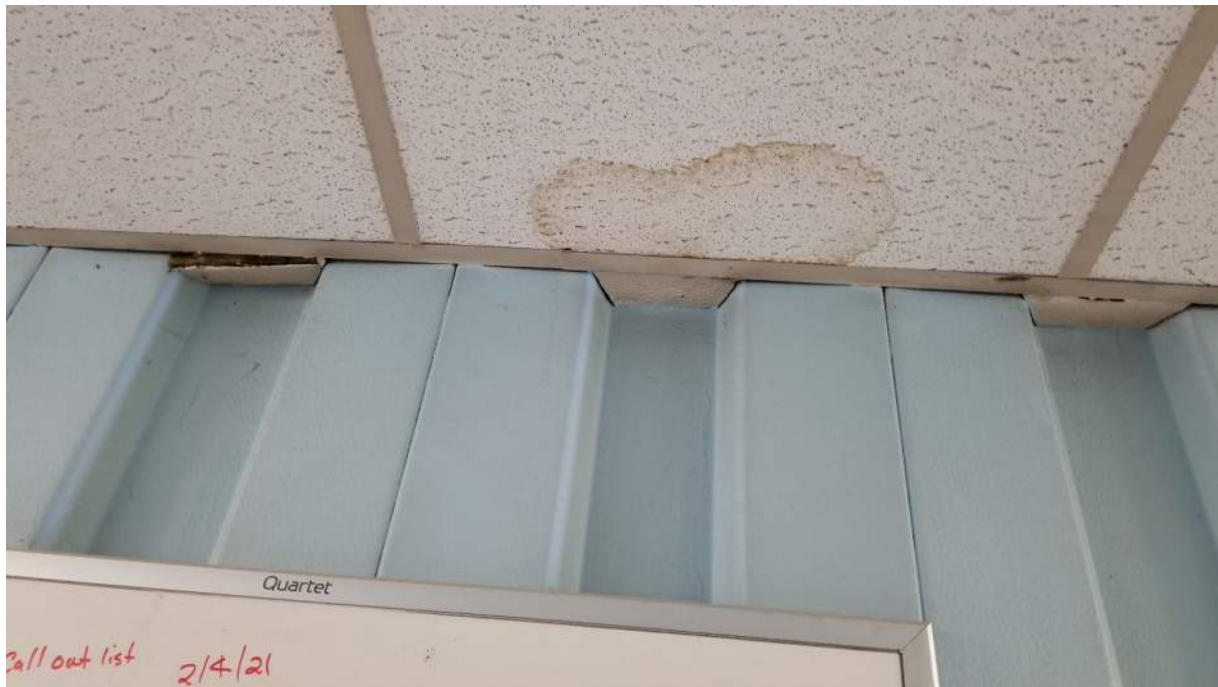
B-10

A17	D	Flooding: There is visible flooding in various areas of the facility (mostly in the pole barn), this should be resolved in any areas of the facility that are to remain.	B-69, B-73, B-102, B-106
A18	O	Kitchen: The Kitchen and the Training space are within the same space. The space is in relatively good conditions and depending on its use if it is to remain any modifications may be minor.	B-25, B-26, B-27, B-28, B-29, B-30
A19	D	Ceilings: The ceiling tiles, ceiling grid and ceiling devices show evidence of water infiltration and would need to be replace if those areas of the building are to remain. In the Garage Areas where the ceiling is insulation, there are many locations that are deteriorating, see Insulation Section for additional information.	B-10, B-12, B-23, B-24
A20	D	Joints: There is some evidence where the portions of the building come together that there is signs of water infiltration or movement. This is true both at the wall of the office-truck storage and at the wall of truck storage-pole barn.	B-9, B-10, B-11, B-34, B-44, B-45, B-56, B-80, B-103

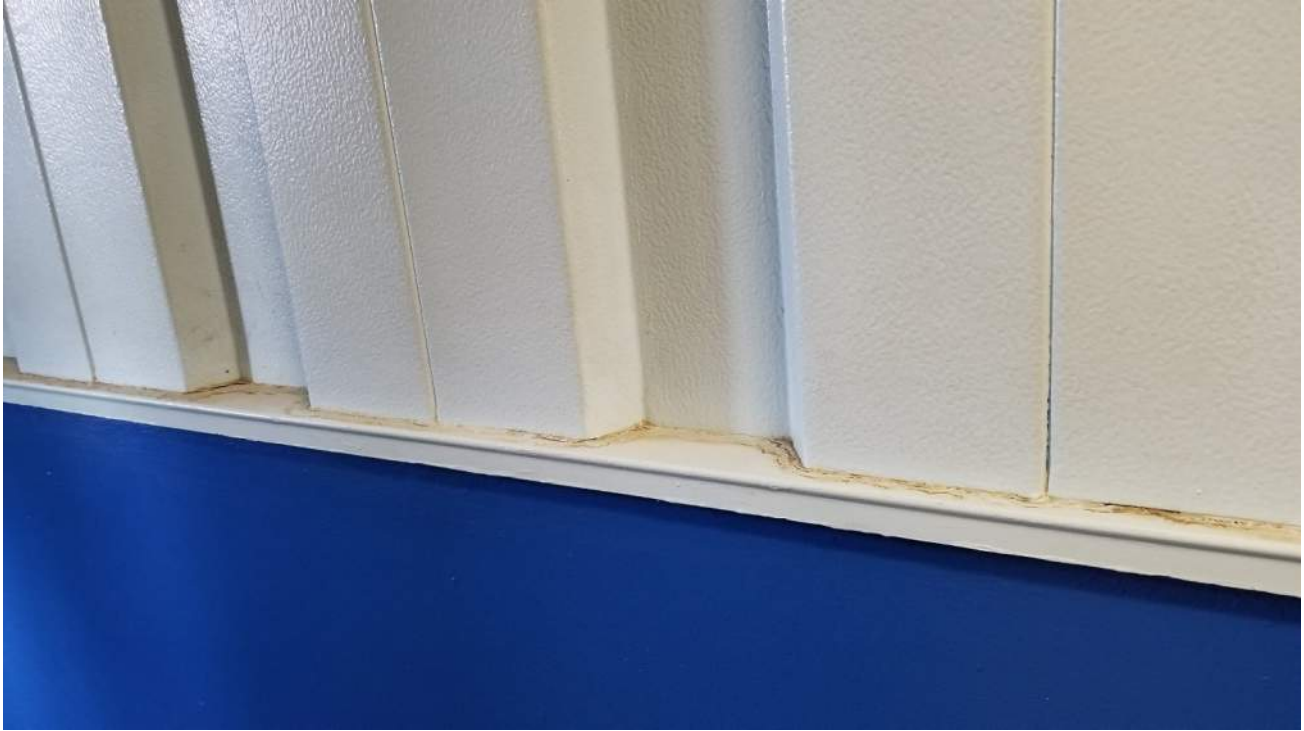
B-31

A21	O/D	Maintenance Bays: The Maintenance Bays, which include a welding bay are congested and not overly efficient, this area should be expanded and rearranged to improve efficiency. Limited overhead space for vehicle repair. Fluids not stored in a separated area.	B-88, B-90, B-95, B-96, B-97, B-86, B-89
A22	O	Office equipment: Servers, copier, and other equipment is intermixed with office workstations and files, with wire management poor. Should consider a separate closet for equipment.	B-7
A23	D	Wet area ceilings: In restrooms and locker rooms, metal ceiling grid is visibly rusting. This is a sign of the finish and integrity being compromised, as well as insufficient ventilation. Should be replaced.	B-14, B-24
A24	D	Sealants throughout the facility are showing signs of age – cracking and delamination – and should be replaced.	B-31, B-35, B-65, B-81, B-82

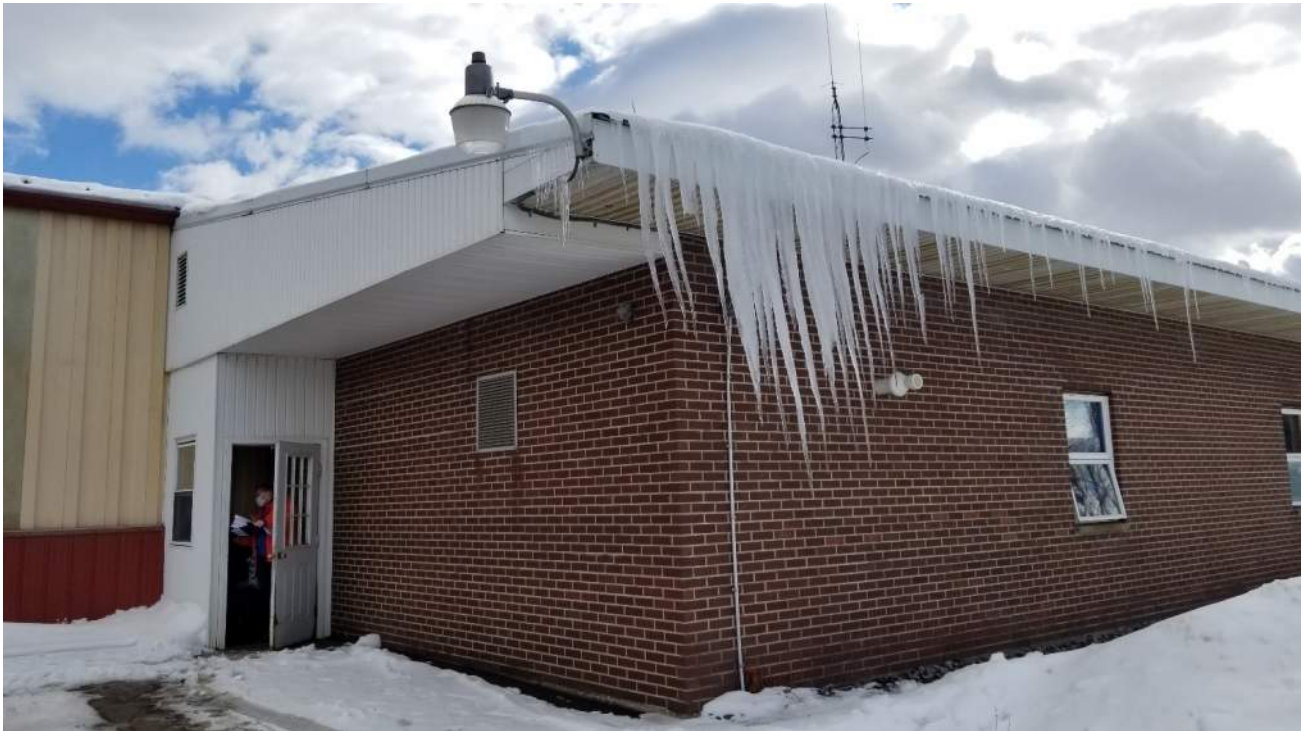
B-38

#	O or D	Condition	Photo
A1	D	Accessibility: Both Office Area Entrances do not meet the ADA Accessibility Requirements, with the public occasionally coming to the facility this should be remedied. Garage Bay Doors swing into the corridor and therefor block some of the egress path.	B-1, B-2, B-40, B-78, B-87, B-8
A2	D	Façade: On all site of the facility there is visible water damage and leakage, if any portion of the building is retained this would need to be corrected. There is also significant ice and snow build up at gutters and	B-38, B-41, B-42, B-43, B-103, B-45, B-46, B-52, B-105

downspouts, some of which is causing damage to the roof in areas. Different color materials are used for the metal panels on the North wall.	
A3	D	Doors: Many of the existing doors and door frames are in bad shape and should be replaced that portion of the building is to remain.	B-13, B-66, B-79, B-84, B-87
A4	O/D	Windows: Office Area windows are in good conditions and could remain if that portion of the building is to remain. If Office portion of the building is to remain the old louver opening in the Boiler Room should be properly infilled.	B-4, B-5, B-32, B-37, B-104
A5	O	Overhead doors: The overhead doors are generally in good conditions and their replacement should be evaluated based on what portions of the building are to remain.	B-49, B-55, B-65, B-91, B-94, B-97
A6	D	Roof: The main field of the roofs appear to be in good condition, the roof edges, fascial, downspouts and gutters however are deteriorating and need to be replaced in any area of the building that is to remain. There is also a lot of ice buildup on all roof edges, which is a sign of insufficient and uneven insulation. In some areas some minor roof repair maybe needed where these items have caused minimal damage. Downspout along West façade shows significant ice damming. All of the insulation under the main garage roof appears aged, damaged, and may contain hazardous materials. Recommend replacement of roof and insulation with insulated metal standing seam panels.	B-38, B-39, B-50, B-52, B-53, B-54, B-103, B-42

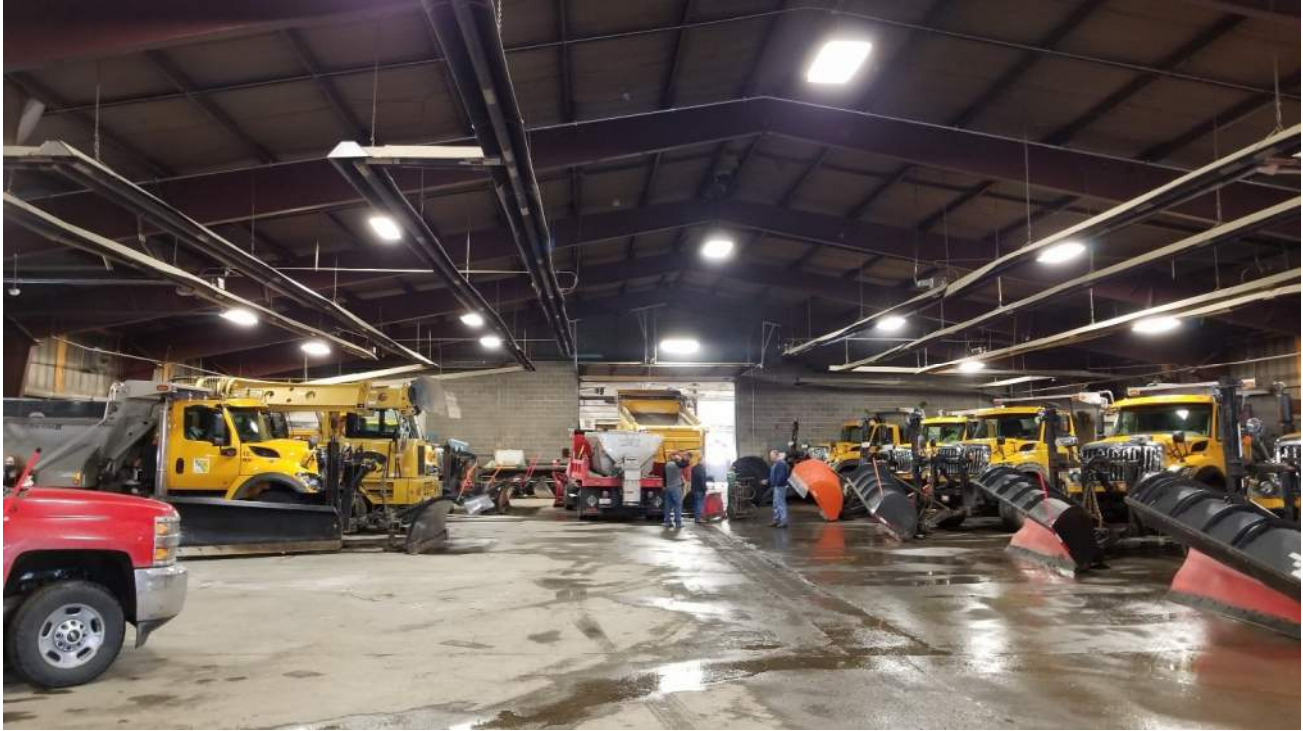
B-62

stored in the locker room. Existing wall tiles have visible cracking. Would be better if locker room was separated from restroom.	
A14	O	Training space: The Training space and the Kitchen are within the same space. The space is in relatively good conditions and depending on its use if it is to remain any modifications may be minor. There appears to be limited counter space for working. Connection directly into locker room seems unnecessary.	B-25, B-26, B-27, B-28, B-29, B-30
A15	O/D	Parking flow: Currently in the parking flow of the Vehicles is to drive in and back into the parking spots. The Vehicles are backing in right up against the walls with no space for a walking area. The Vehicles are parked with their front attachments on. Currently, ingress and egress are through the same overhead door.	B-61, B-62, B-63, B-64
A16	O/D	Vehicle equipment: The Vehicle equipment is in relatively good condition. However, there is insufficient space for air compressor behind parked trucks, tools storage, chains storage, etc.	B-61, B-62, B-63, B-64, B-71, B-70, B-74

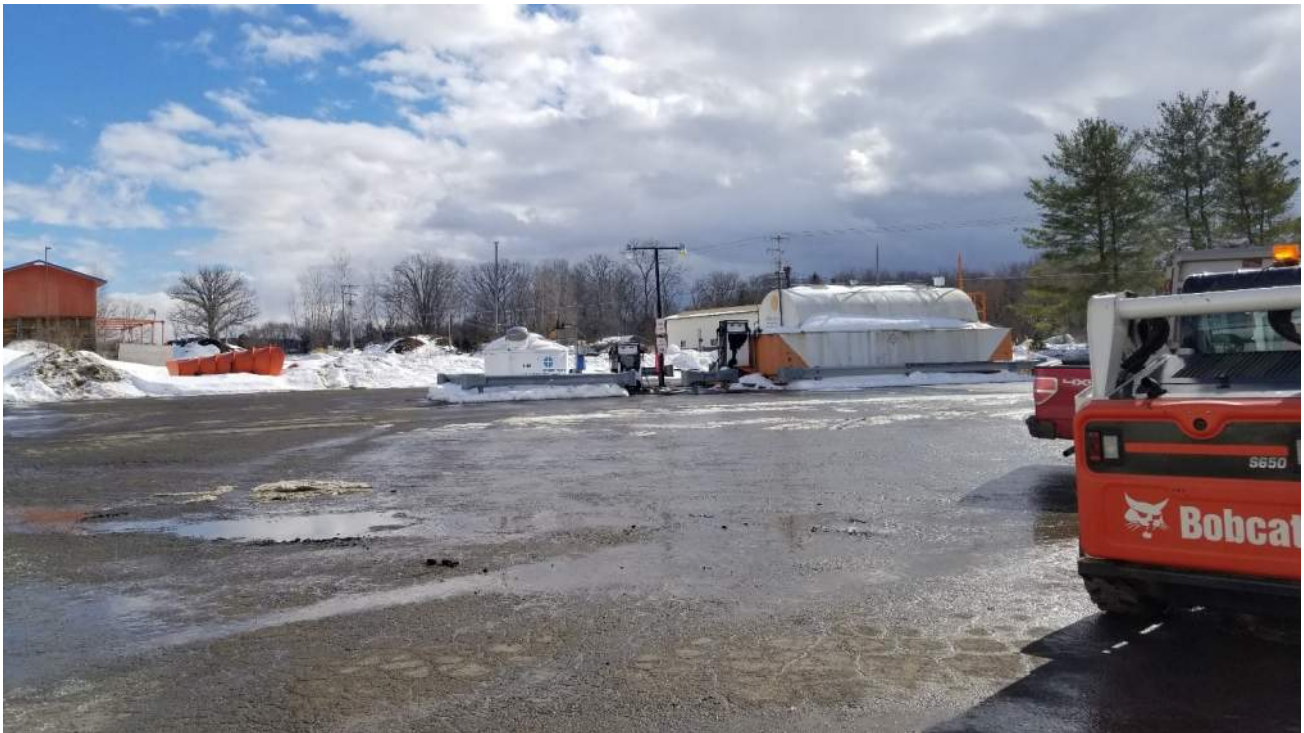
B-76

A31	O	Mezzanine guard rail should be checked for code compliance if remaining	B-85
A32	O	Fuel island shows age and will need to be replaced with new tanks and equipment soon	B-98, B-76, B-100

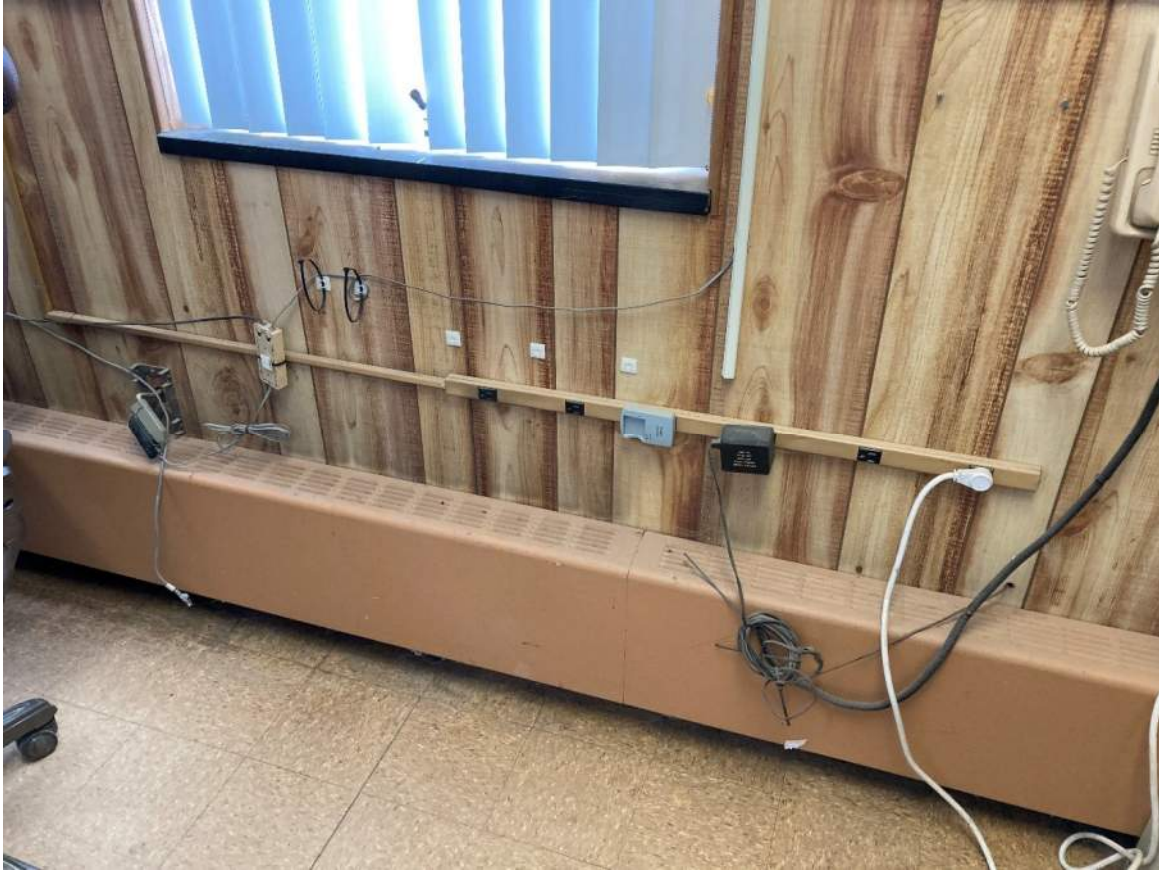
E8	D	Exit signage was primarily in the form of non-illuminated exit signs which should be replaced with illuminated battery backed exit signs that will remain lit in the event of a power outage.	B-134
E9	D	The facilities Fire Alarm System (FAS) is a Honeywell conventional zonal system. There are many smoke detectors installed in the office and garage areas and some horn/strobe units. The horn/strobes are sparingly located in most spaces and would require more to be code compliant.	B-133 B-148
E10	D	Facility branch circuit wiring and conduit system varies in condition with the original buildings having old and rusting conduits and the newer additions in better condition. As with the branch circuit panel feeders many branch circuits are within conduits below grade that are periodically failing. Additionally, there are locations where receptacles are located above baseboard heaters.	B-149 B-150 B-158 B-159
