# Facility Conditions Assessment

## Town of Lansing Highway Department Building

**Final Report**  
**November 10, 2021**

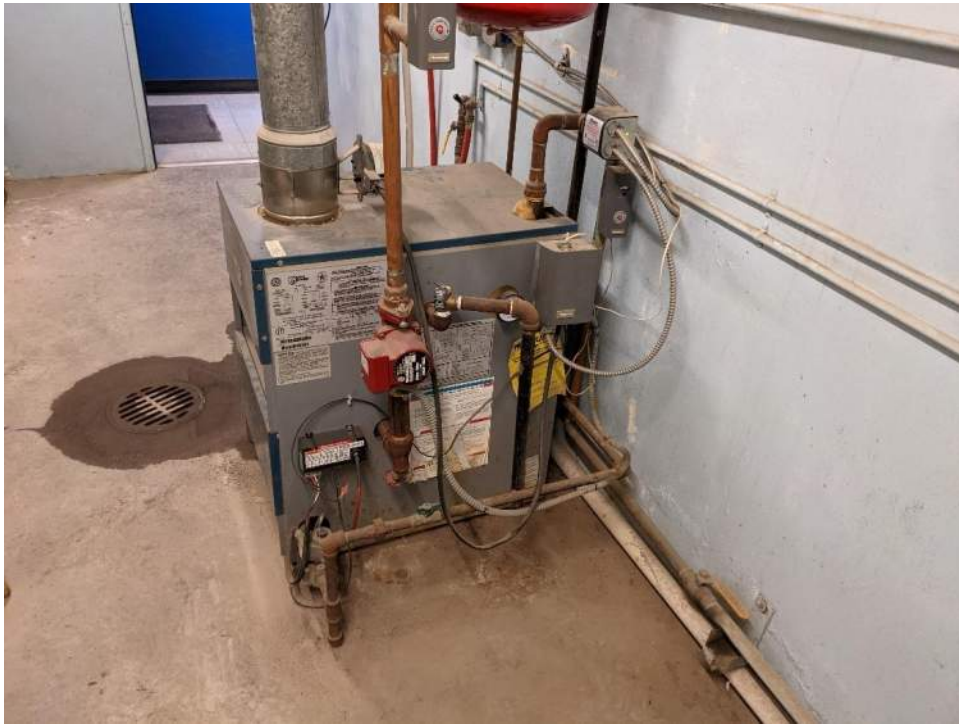
Boiler located in Boiler Room.

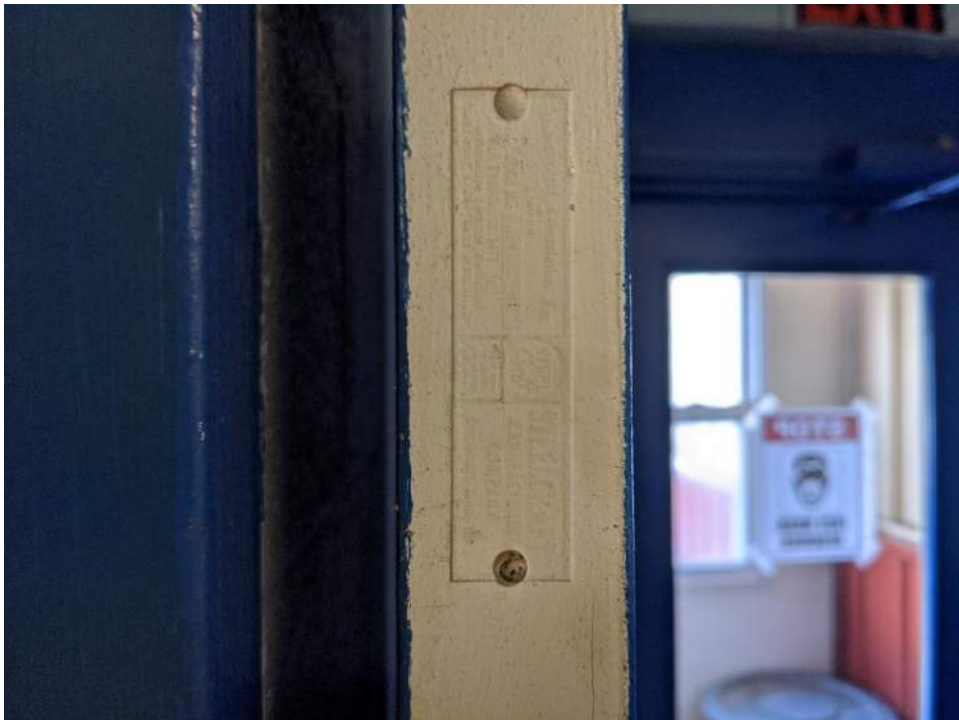
Fire door at entrance of Boiler Room.

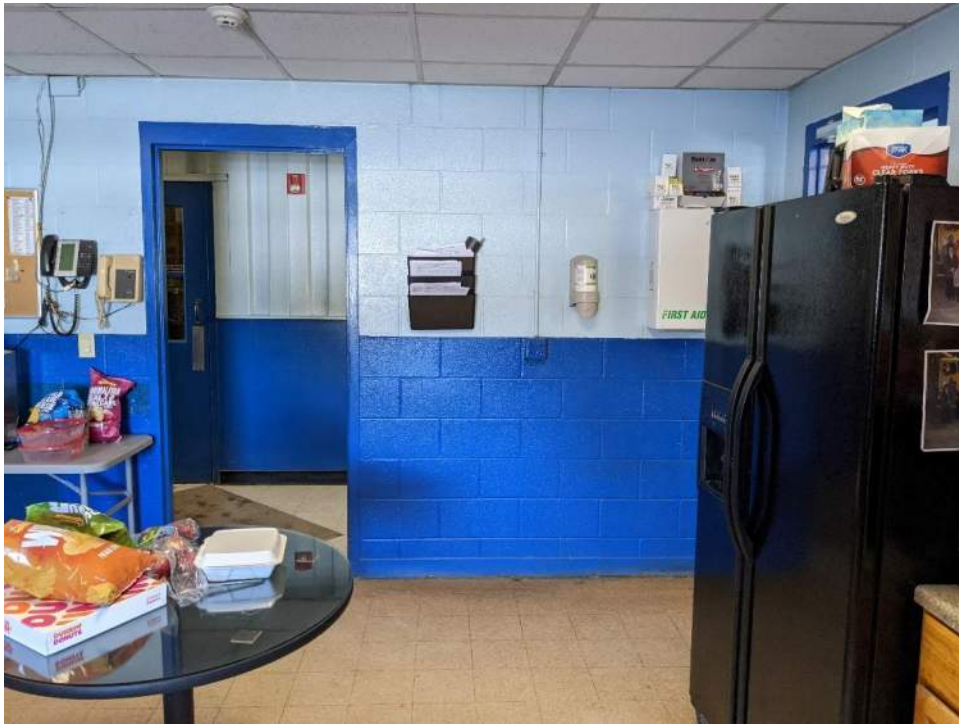
Break Room, facing east.

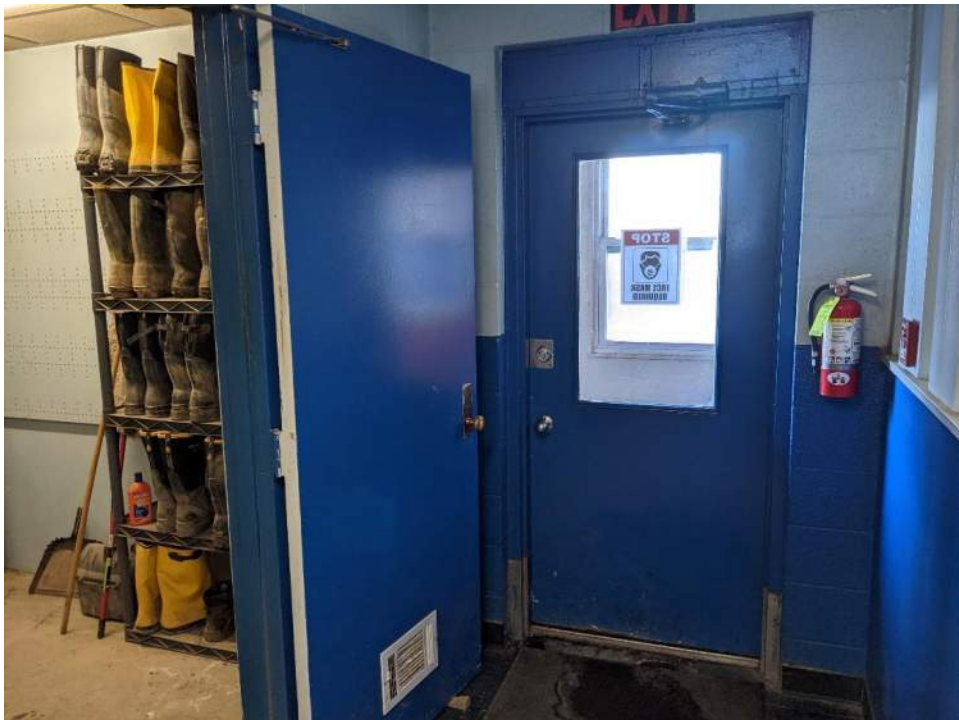
North end of corridor outside Boiler Room.

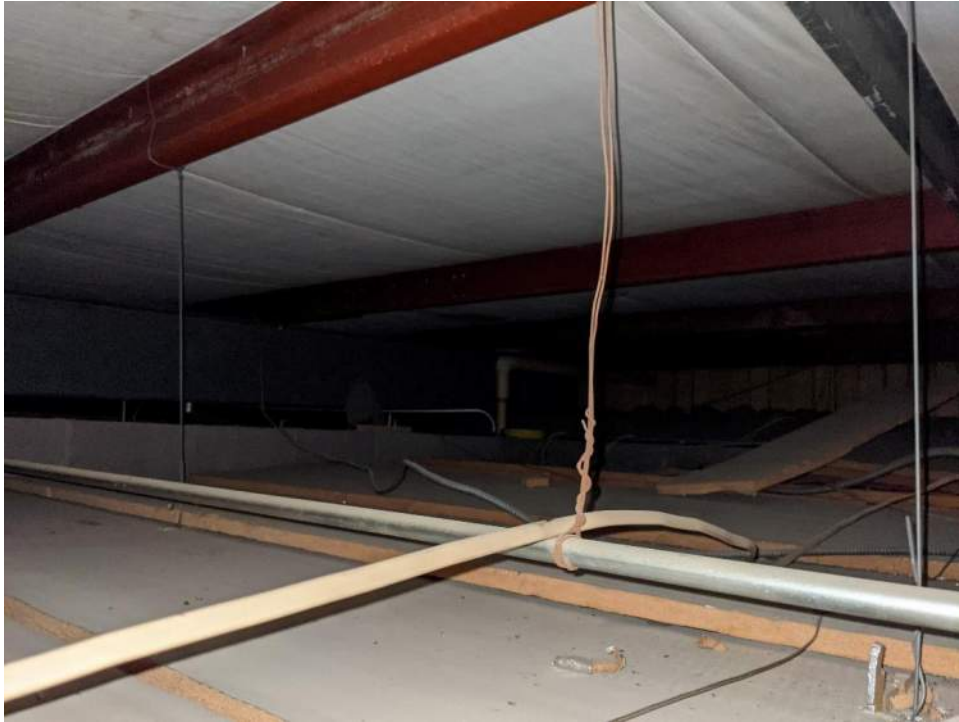
Silver and Loose Insulation Panels above Office

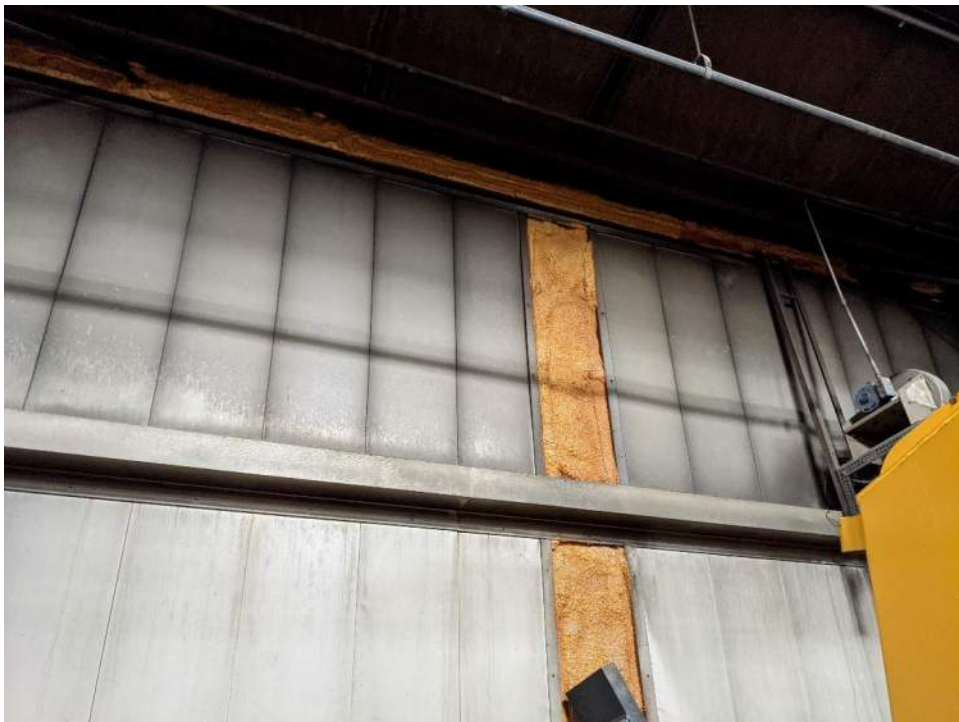
Yellow spray foam at former window openings.

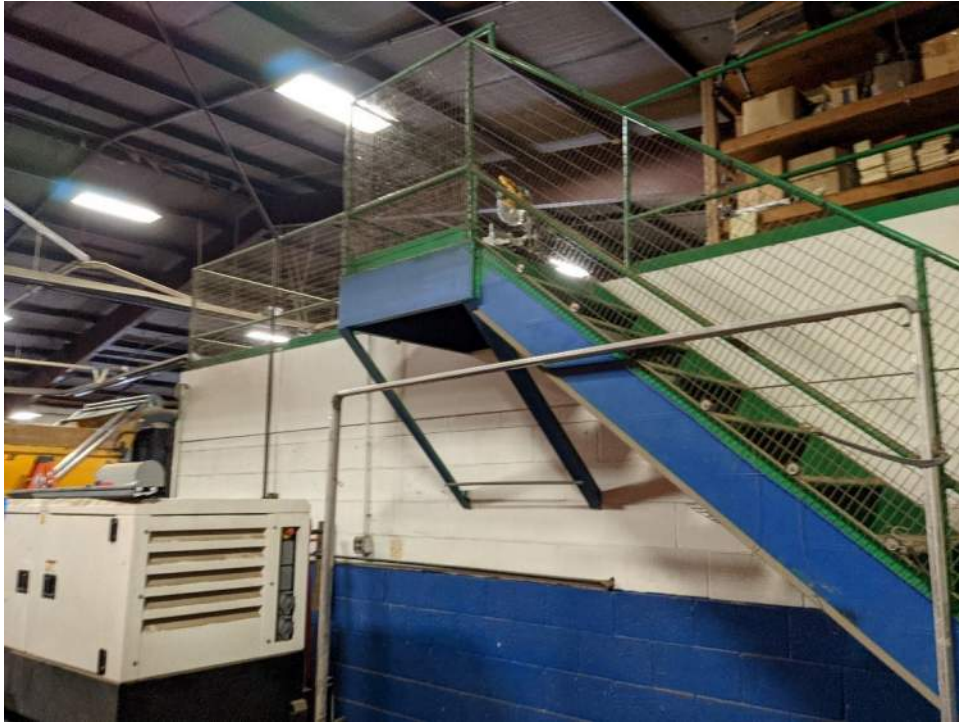
Facing south in southeast portion of garage.

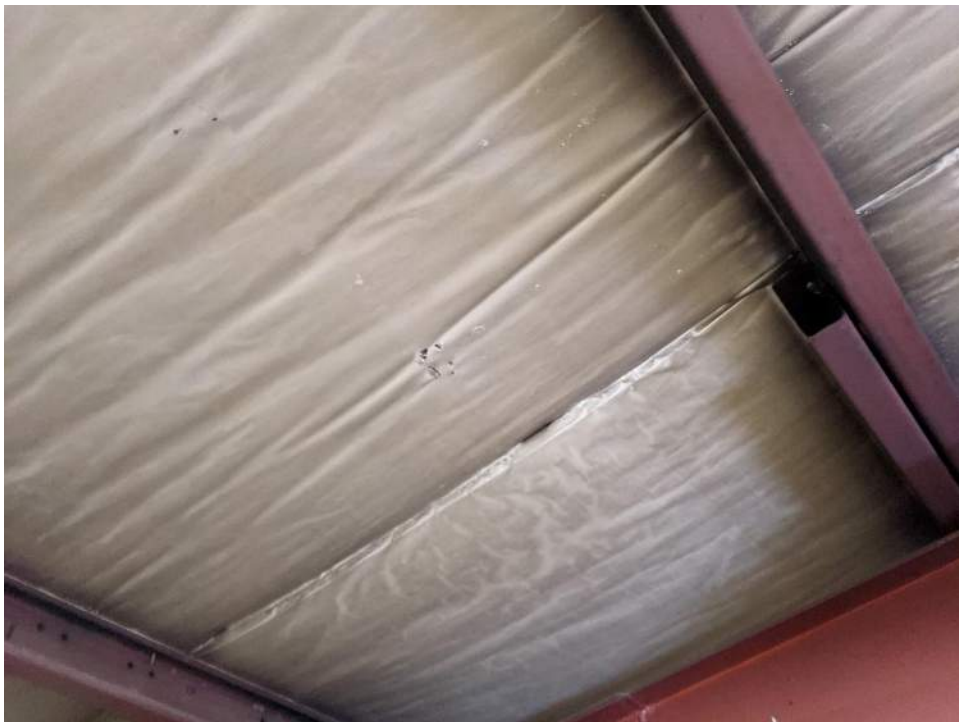
Ceiling insulation and red structural paint.

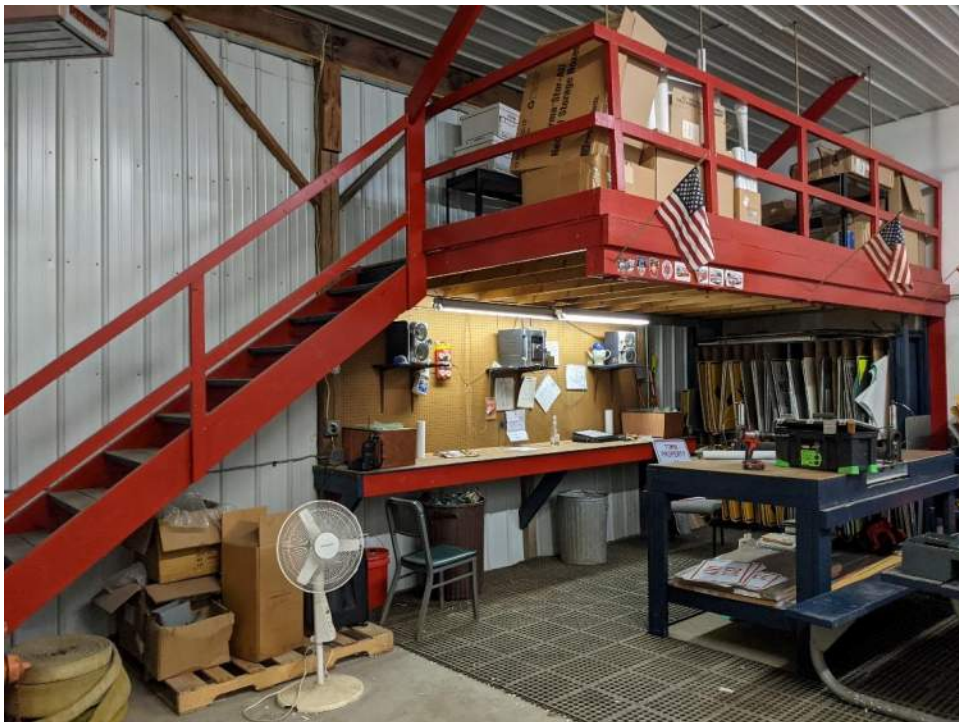
Facing northeast in sign room.

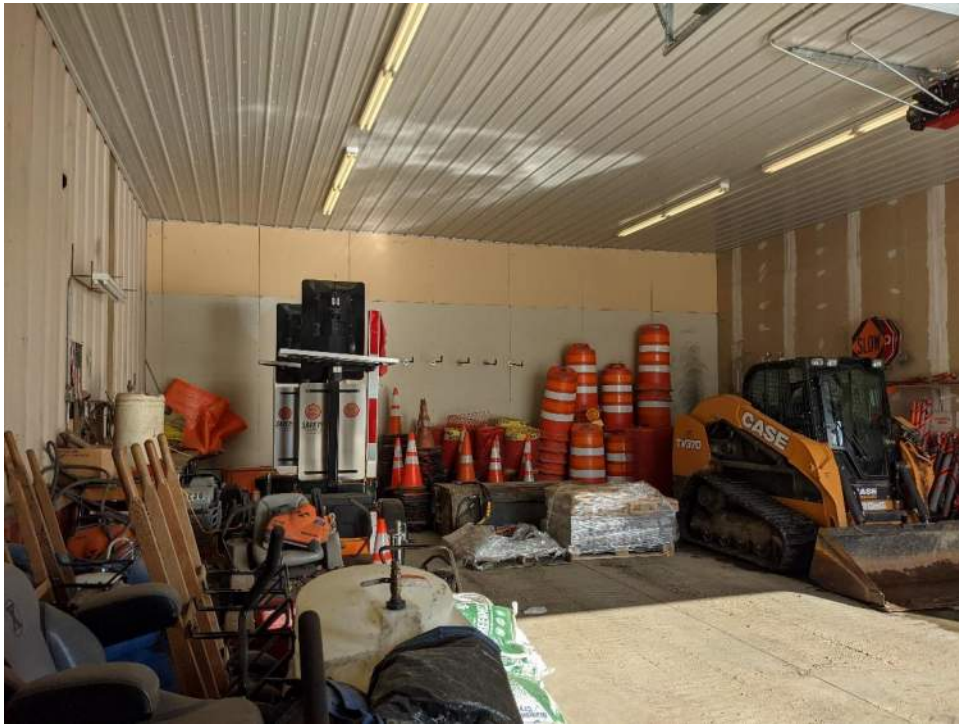
Facing north in equipment room.

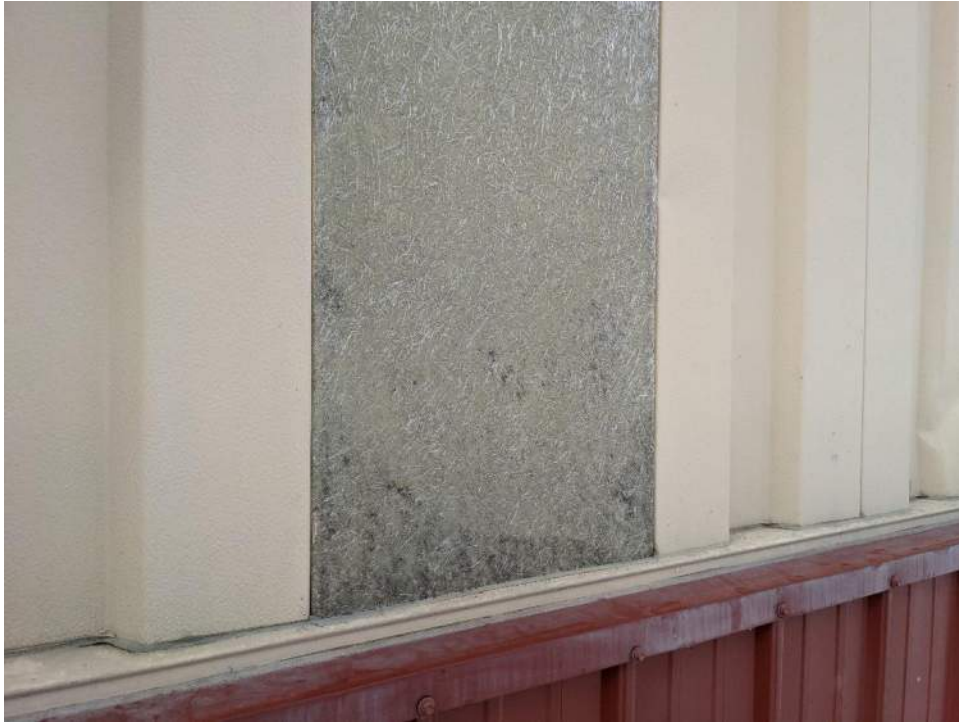
Facing west at exterior.
