# Facility Conditions Assessment

## Town of Lansing Highway Department Building

**Final Report**  
**November 10, 2021**

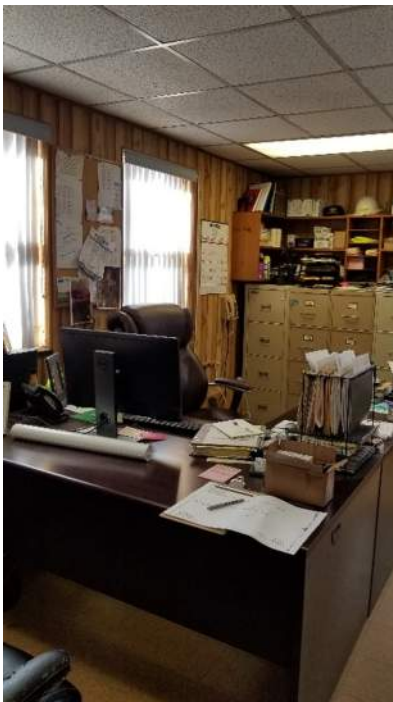
B-3

A7	O	Offices: Space is good conditions but is not big enough for current needs and does not have adequate separation from other spaces. Offices also have more power demands than current capacity.	B-3. B-6
A8	D	Brick: In areas of excessive water build up the brick is both deteriorating and is coated in efflorescence. Any bricks in the are to remain would need to be repointed and repaired, as necessary.	B-35, B-36, B-80, B-82
A9	D	Floor cracking: Many portions of the concrete floor have visible large cracks, see Structural Section for repair and additional information. Concrete floors in areas to remain are to be repaired.	B-51, B-68, B-72, B-93
A10	O	Trench drains: Trench drains appear to be in relatively good condition, see Plumbing Section for additional information.	B-73, B-75, B-92
A11	D	Insulation: The facility has many insulation issues that have been repaired over time. These repairs should be removed and replaced in any areas of the facility that are to remain. Areas of exposed spray foam insulation should be properly covered.	B-33, B-45, B-46, B-52, B-57, B-58, B-60, B-65, B-67

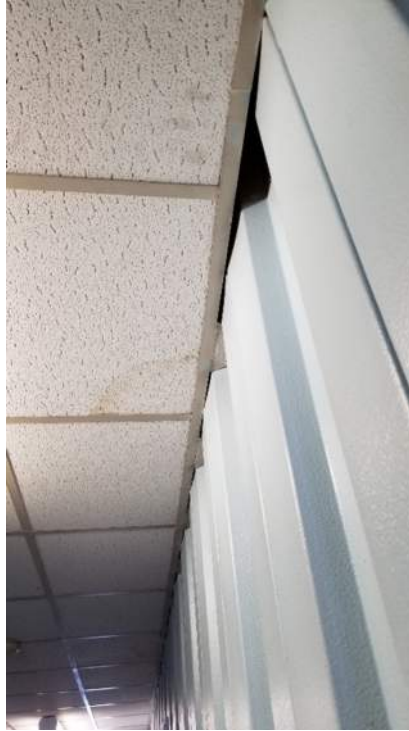
B-9

A17	D	Flooding: There is visible flooding in various areas of the facility (mostly in the pole barn), this should be resolved in any areas of the facility that are to remain.	B-69, B-73, B-102, B-106
A18	O	Kitchen: The Kitchen and the Training space are within the same space. The space is in relatively good conditions and depending on its use if it is to remain any modifications may be minor.	B-25, B-26, B-27, B-28, B-29, B-30
A19	D	Ceilings: The ceiling tiles, ceiling grid and ceiling devices show evidence of water infiltration and would need to be replace if those areas of the building are to remain. In the Garage Areas where the ceiling is insulation, there are many locations that are deteriorating, see Insulation Section for additional information.	B-10, B-12, B-23, B-24
A20	D	Joints: There is some evidence where the portions of the building come together that there is signs of water infiltration or movement. This is true both at the wall of the office-truck storage and at the wall of truck storage-pole barn.	B-9, B-10, B-11, B-34, B-44, B-45, B-56, B-80, B-103

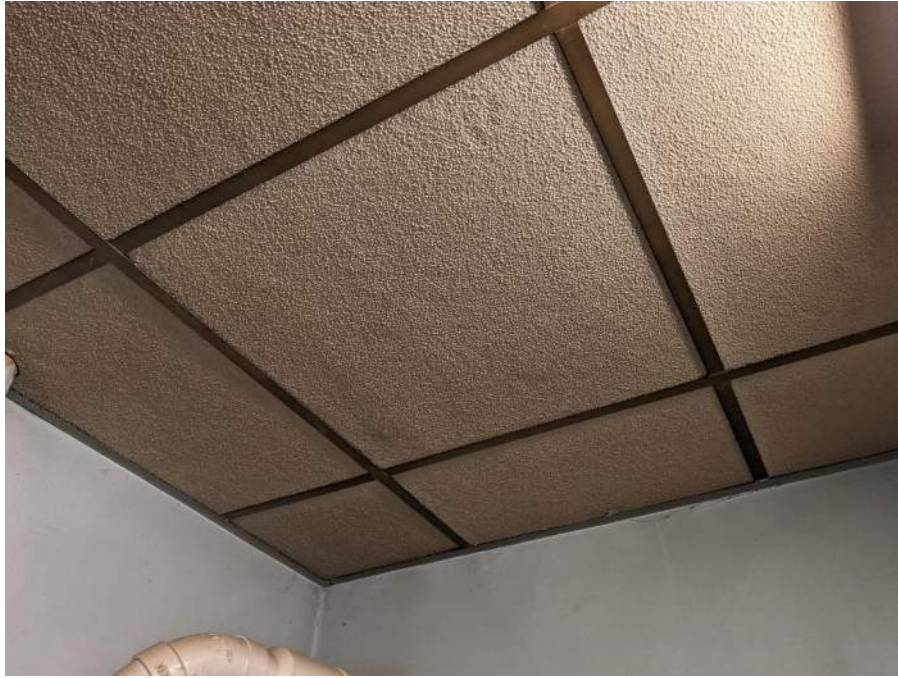
2-Foot by 2-Foot Off White Textured Ceiling Tile.

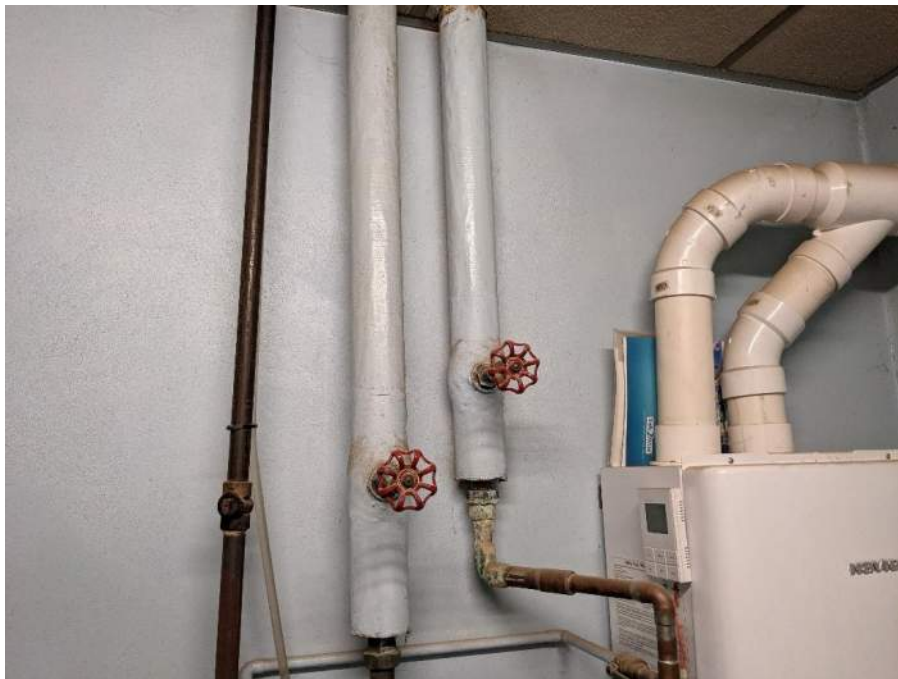
Off White Cloth Jacket and Muddied Fitting TSI.

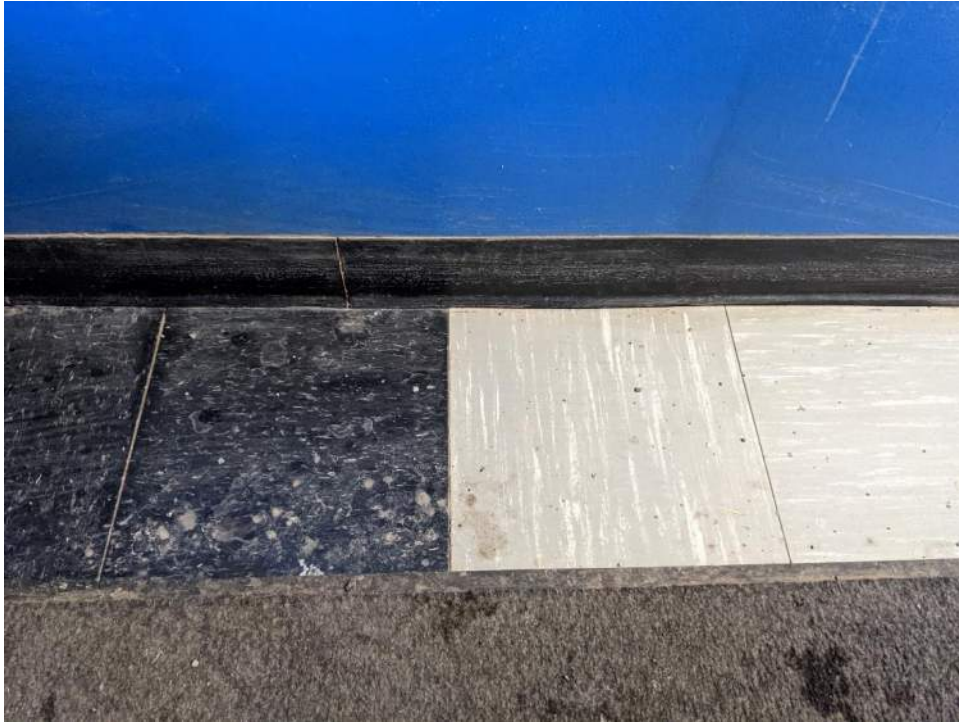
Black 3-In Cove Base, 12-by 12-Inch Floor Tiles

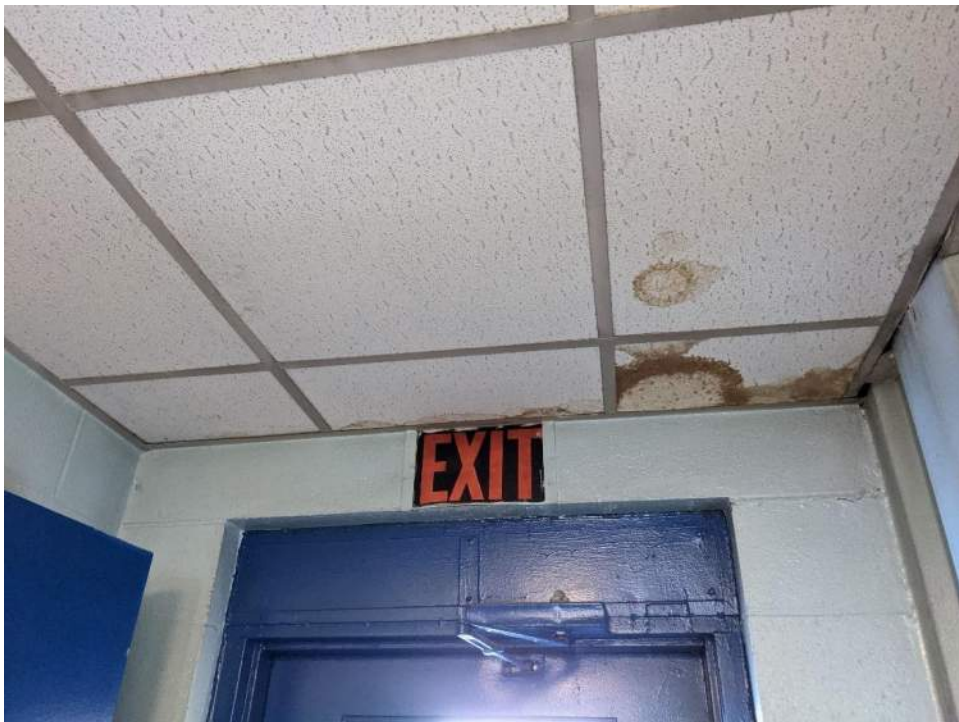
White 2-Foot by 2-Foot Pinhole and Fissure Ceiling Tile.

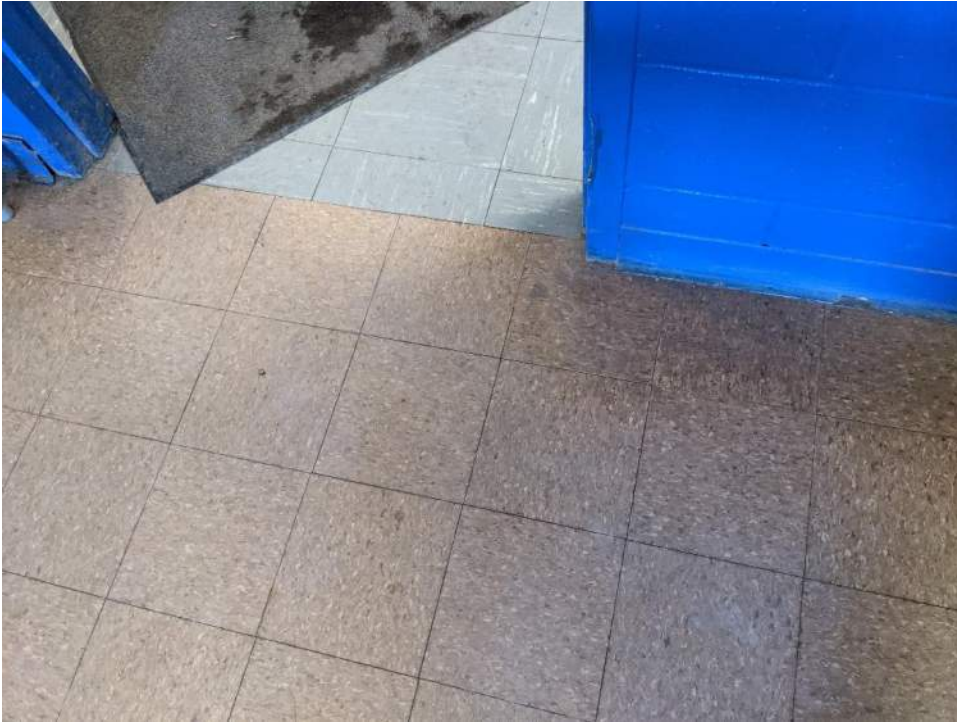
Tan 9-by 9-Inch Floor Tile.

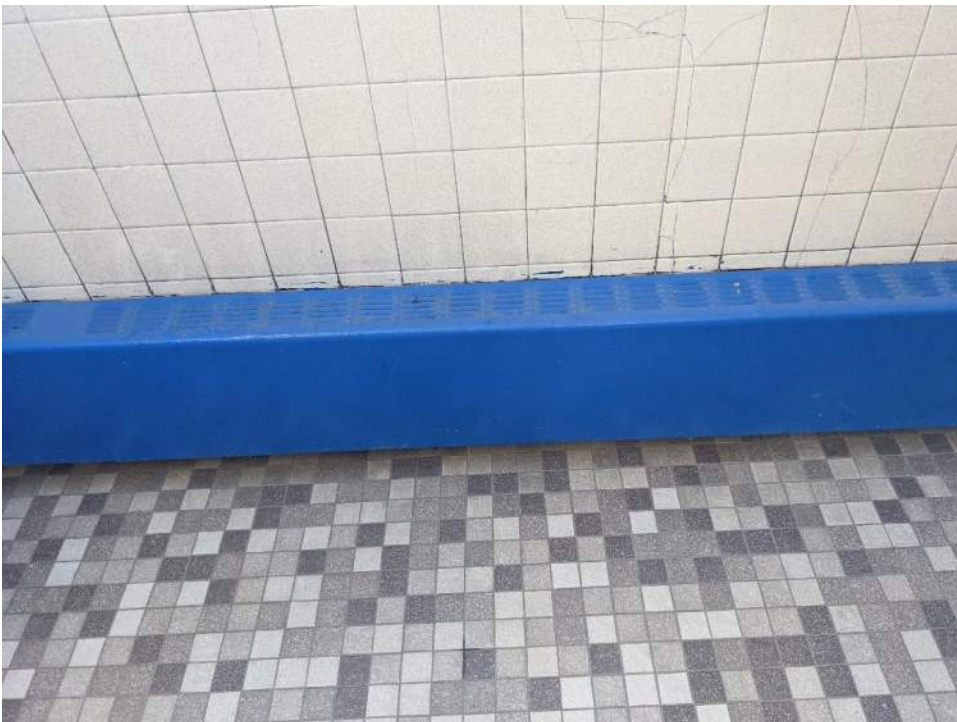
3-by 3-Inch Ceramic Wall Tile, 2-by 2-Inch Ceramic Floor Tile.

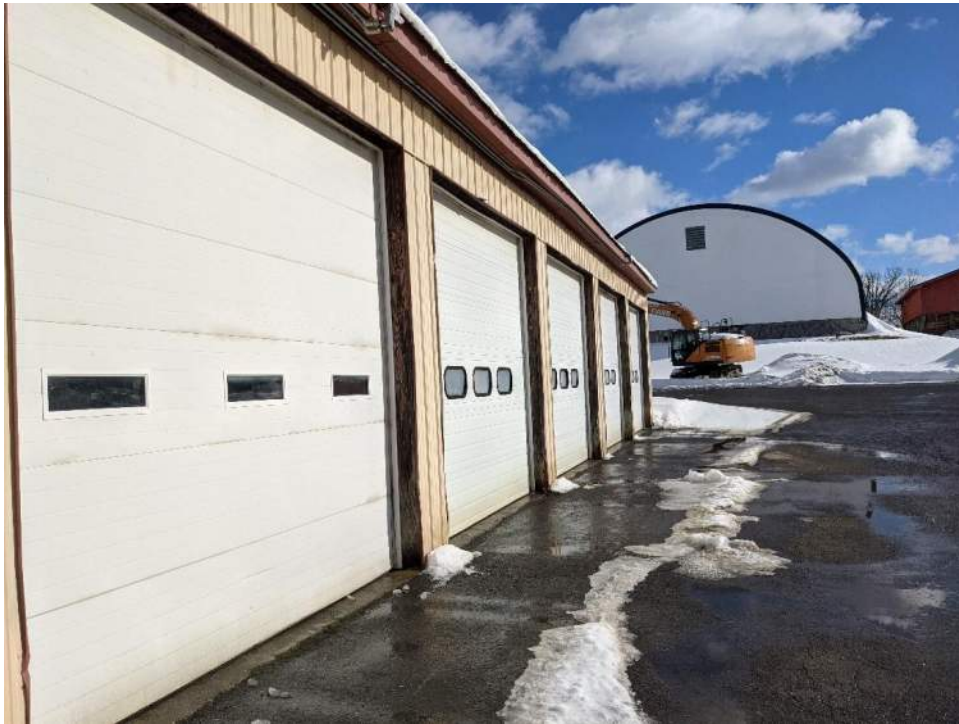
Facing east in equipment room.

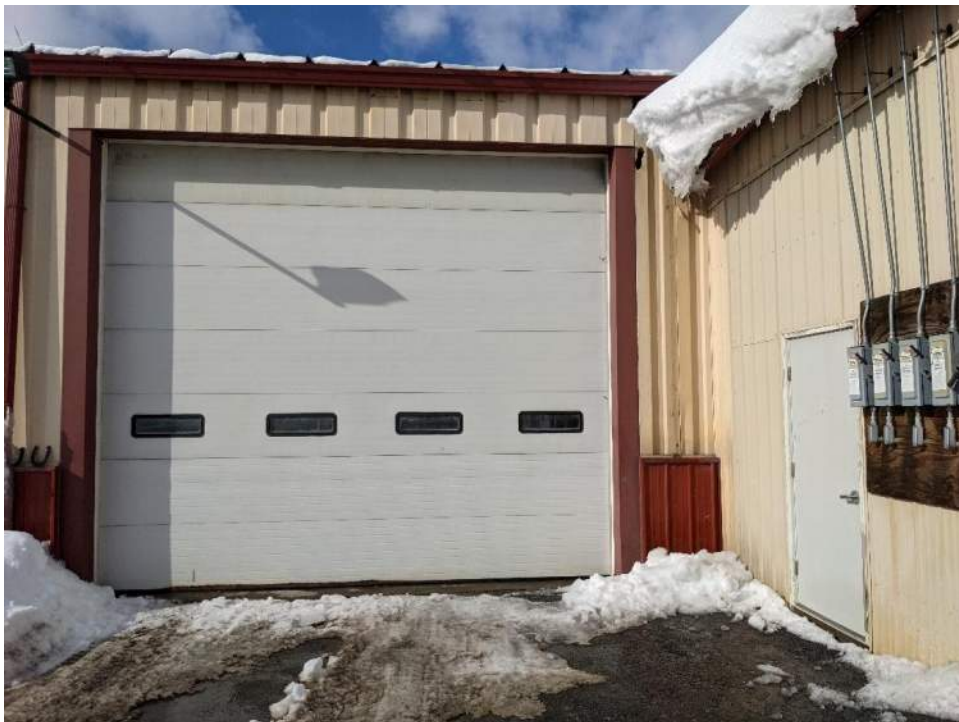
Facing northeast at exterior.
